THE FABRIC OF CARS' EXISTENCE

For decades, fabric-bodied cars have had to be restored with incorrect PVC coverings. Now, after an amazing salvage operation, that's no longer the case

BODY-FABRIC MACHINE

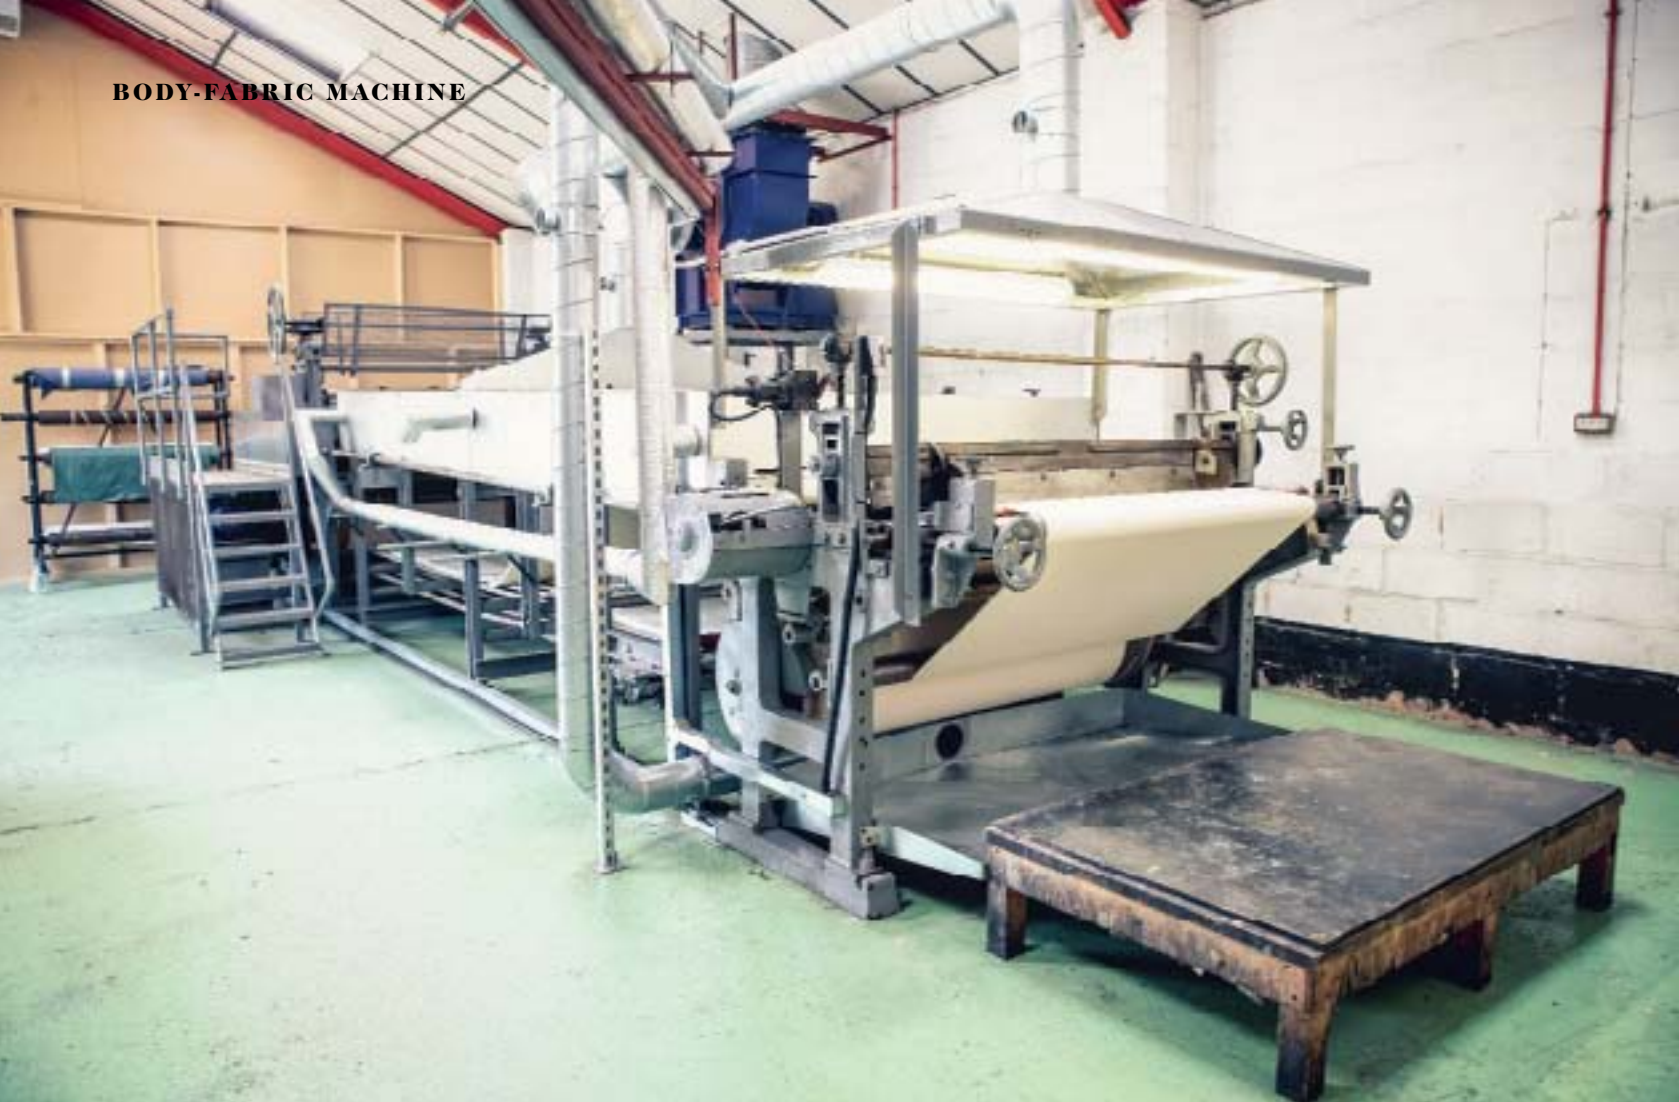
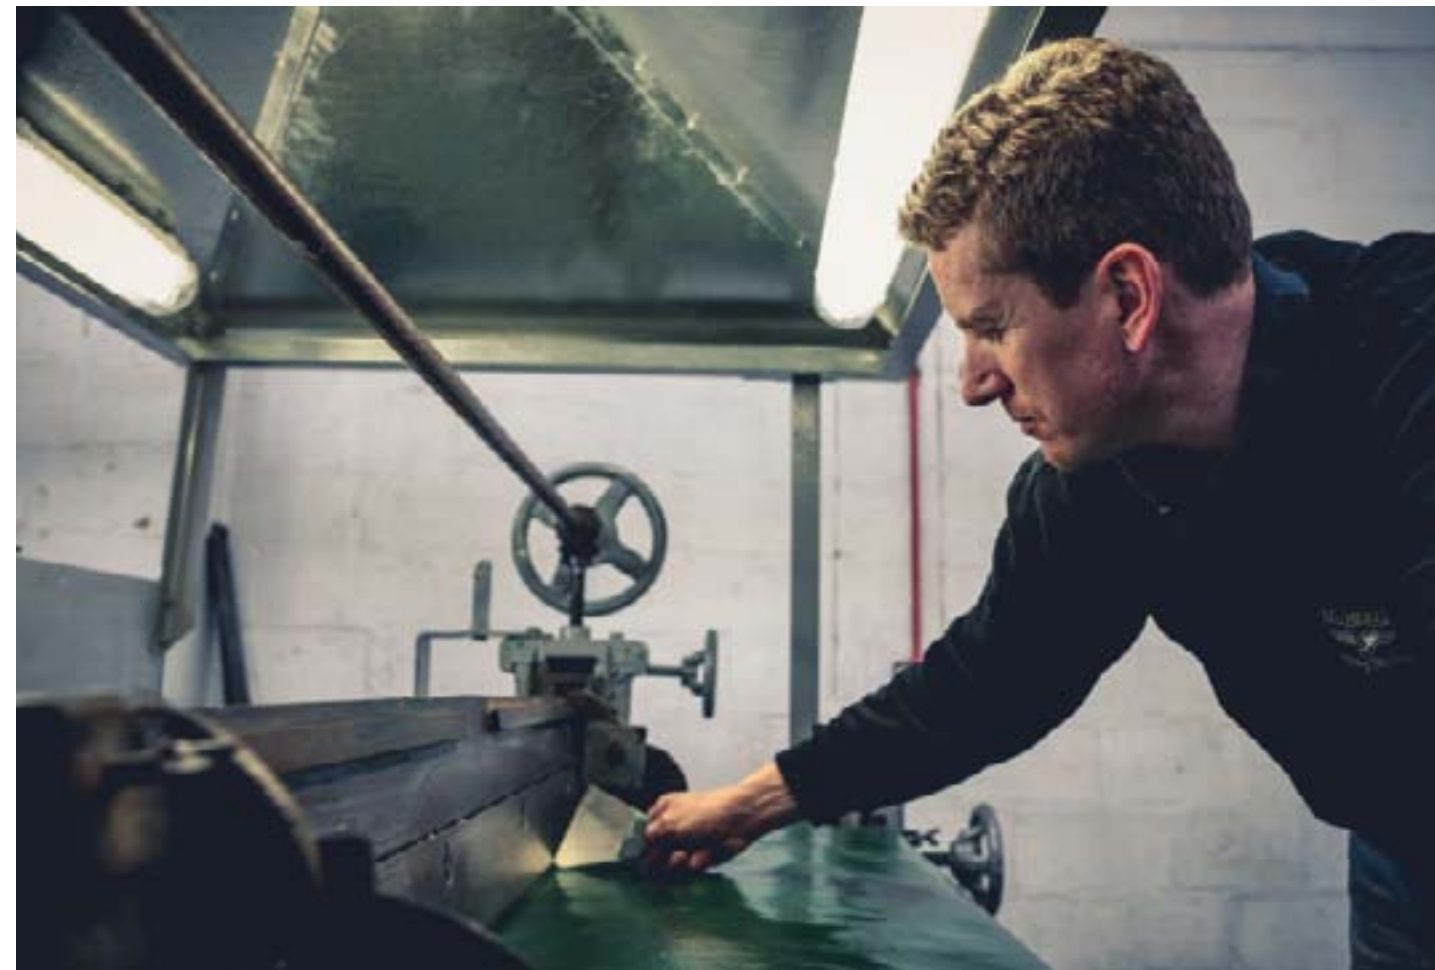
Graham swings open the doors to reveal a piece of machinery that looks run-of-the-mill, until a closer look reveals steam-age sprockets, drive chains, levers, dials and rollers that clearly don't belong in this century.

This, however, is the future – at least, it might be if you have a fabric-bodied car. The machine you see here enables the correct fabric to be used, rather than the PVC (in a limited range of colours, including just one shade of British Racing Green) that is all that's been available for fabric body restoration since the 1960s.

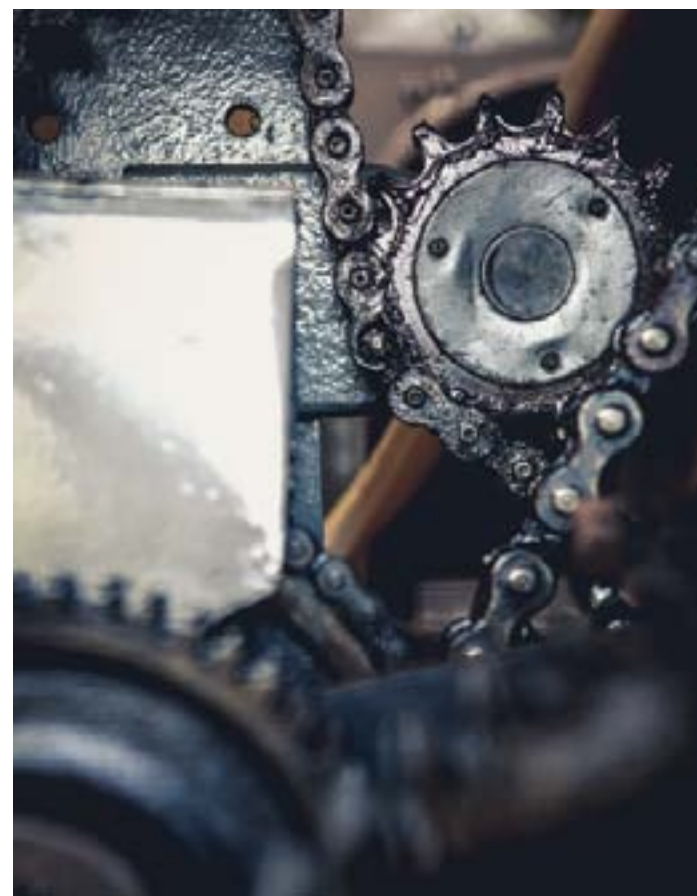
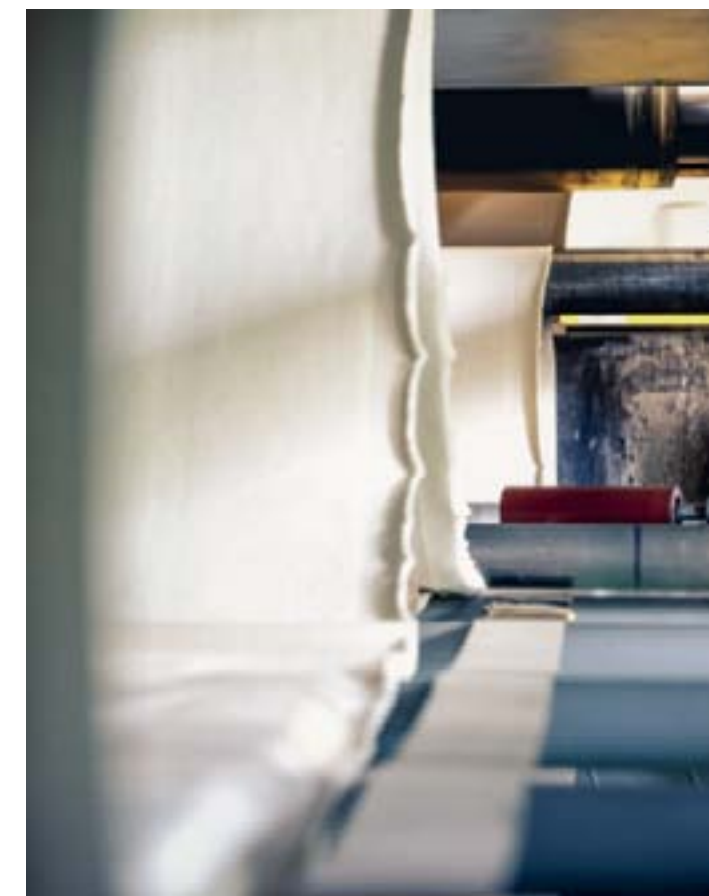
Above and right
The marvellous fabric machine, which in operation clanks and hisses like something out of *Charlie and the Chocolate Factory*; Graham Moss scrapes away excess paint using a broad-bladed palette knife.

Graham works at one end of the machine, standing on a rubber mat to avoid static electricity build-up, scraping away excess paint with a knife. In the past, operators would climb up to the machine and tap the knife onto the end roller to earth any static, and so now the roller is pock-marked from decades of those little taps.

Another operator works from the opposite end, where a water-heated roller pulls the fabric through under tension. As the fabric starts to move – at some lick, it has to be said – Graham pours the paint mix (or sealant or top coat) onto the fabric, and a Stellite-tipped blade scrapes almost all of it away, leaving an initially invisible coating. The varying thickness and imperfections of the fabric are allowed for by a thick rubber blanket on the roller beneath the stellite blade, keeping the coating uniform at all times. Graham has to adjust barge boards on either side to keep the coating within 5mm of the fabric edges at all times.

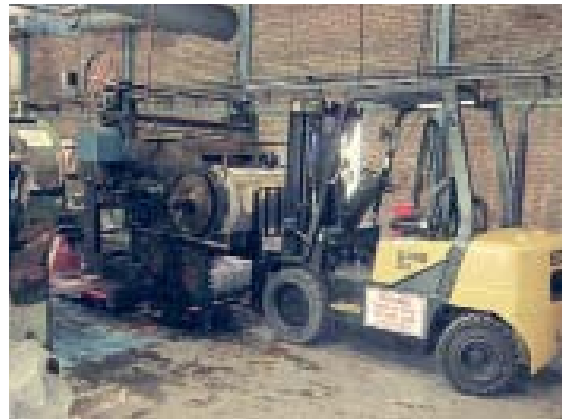
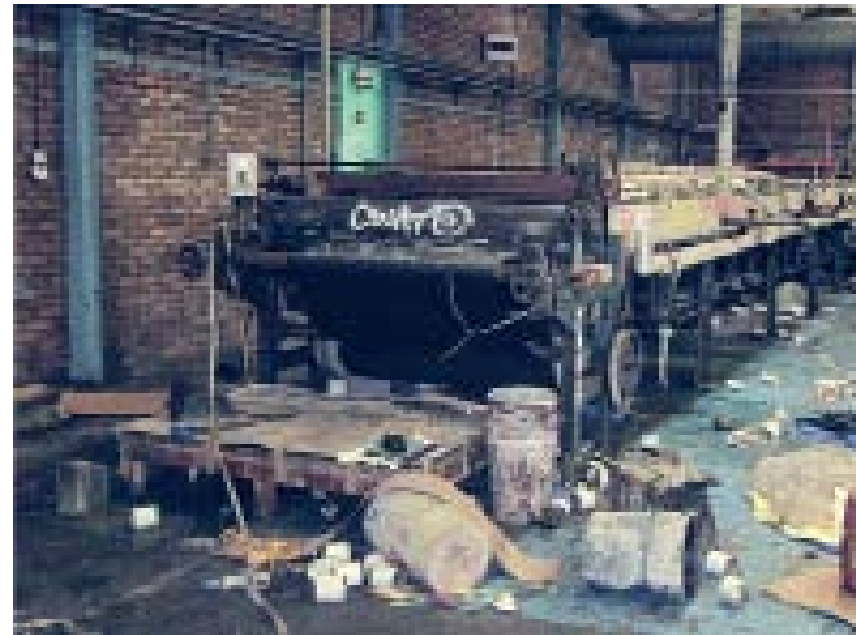
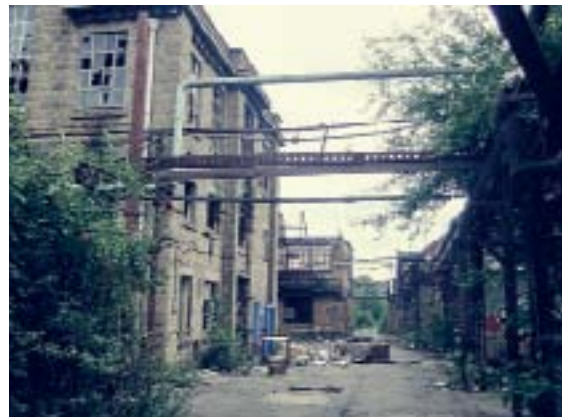
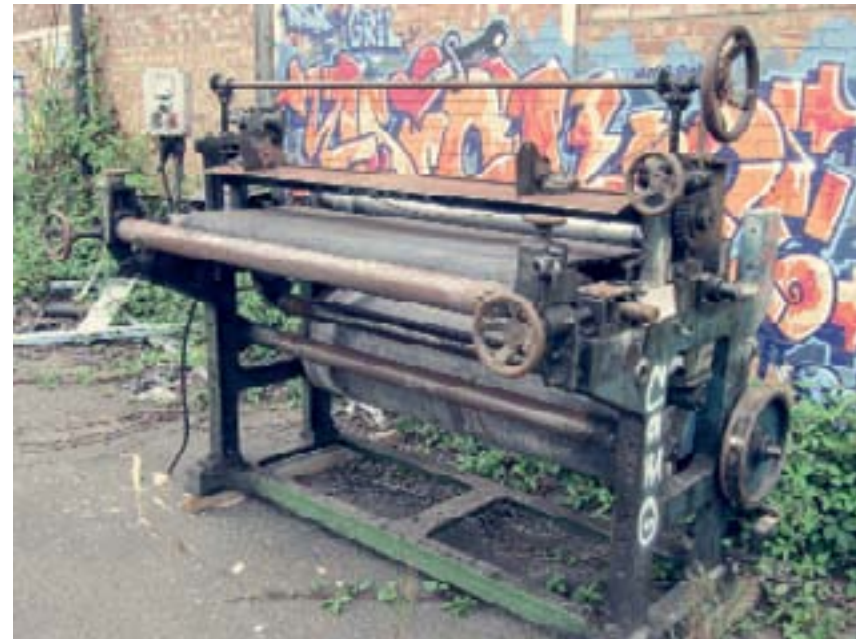
Below
The Wardle Storeys factory, as found mid-demolition by Graham Moss. In fact the narrow access tunnel (bottom left) has prevented further demolition work to the part of the factory that the machine was found in.

'We found the machine. It was 25-metres long and steam-heated. I thought, no, this is ridiculous! We'll walk away!' All the same, Graham mentioned the factory to Peter Livanos. 'I said to him "I wasn't going to tell you because I know what you'll say." And, of course, he said it – that we should rescue the machine. It's been a nightmare ever since! I kept thinking it over and finally I had a eureka moment – "Why do I need the oven?" – because either end of the machine was generic. I could take the ends, and halve the length of the machine.'

'I arranged to buy it for scrap value, meeting in a layby with cash in an envelope. Only then was I told that the lagging round the heating tubes might be asbestos! I had to employ a man in a spacesuit to go in and analyse it. Turned out it was plaster of Paris. Then we had to work out how to get the machine out through the tunnel. We found a company that specialised in storm drain work, and they used a lowloader to drag it out.'

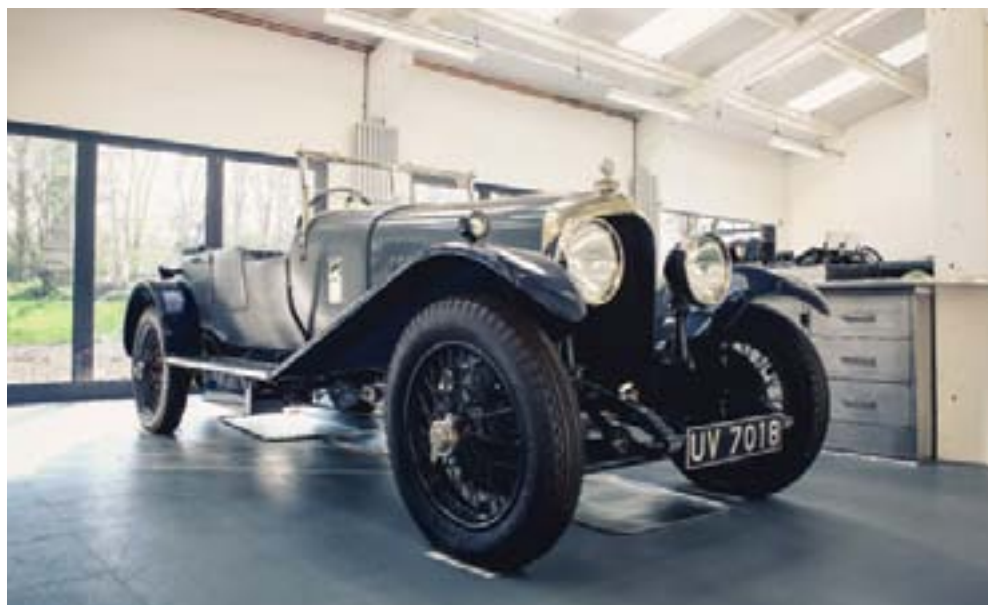
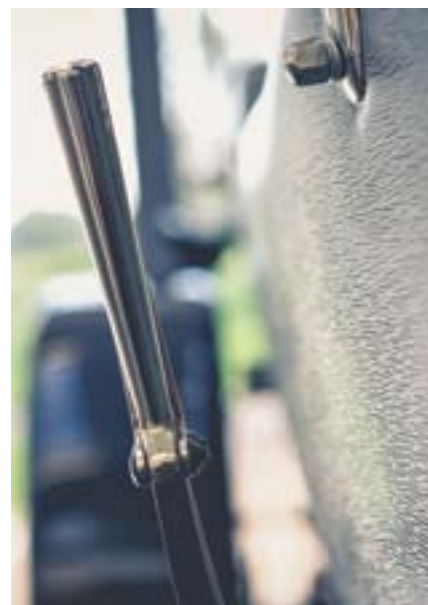
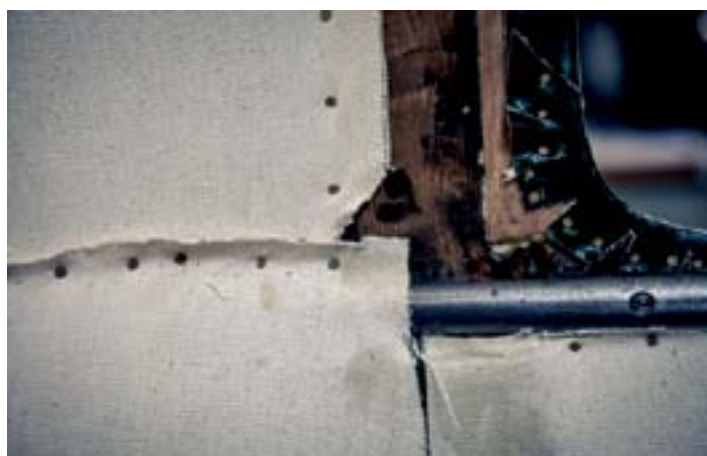
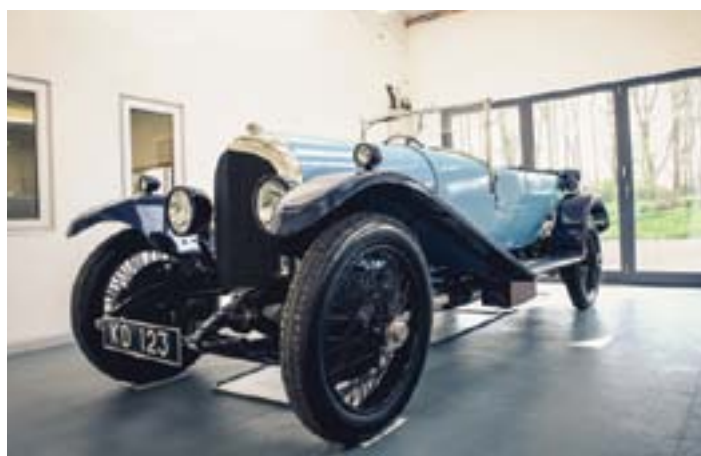
Above
The two finished cars: UV 7818, a 4½ with embossed fabric; and KD 123, a 3 Litre with smooth fabric. Graham uses a modern machine with custom-made roller for the embossing; the 'grain' (top right) must remain straight, so embossed fabric can only be used on square-backed bodies. The close-up (bottom left) shows what's underneath a Le Mans-type body covering.

And after the magic? That's the (relatively) easy bit, because although re-upholstering a fabric body is a highly skilled process, it's much quicker than scratch-building aluminium panels – but with all that's involved with the fabric production, it's not much cheaper. The fabric is stretched around the frame, then padded out with horsehair to achieve the correct contours.

Several cars are now underway, and two have been completed: a Bentley 3 Litre and a 4½, both belonging to Peter Livanos, and due to be unveiled at Pebble Beach Concours this year. They look incredible, noticeably different from PVC-bodied machinery. The vintage car world is about to be thoroughly shaken up. **Car**
